Stress Analysis of the F-111 Wing Pivot Fitting

S. Weller and M. McDonald

DSTO-TN-0271

**Airframes and Engines Division
Aeronautical and Maritime Research Laboratory**

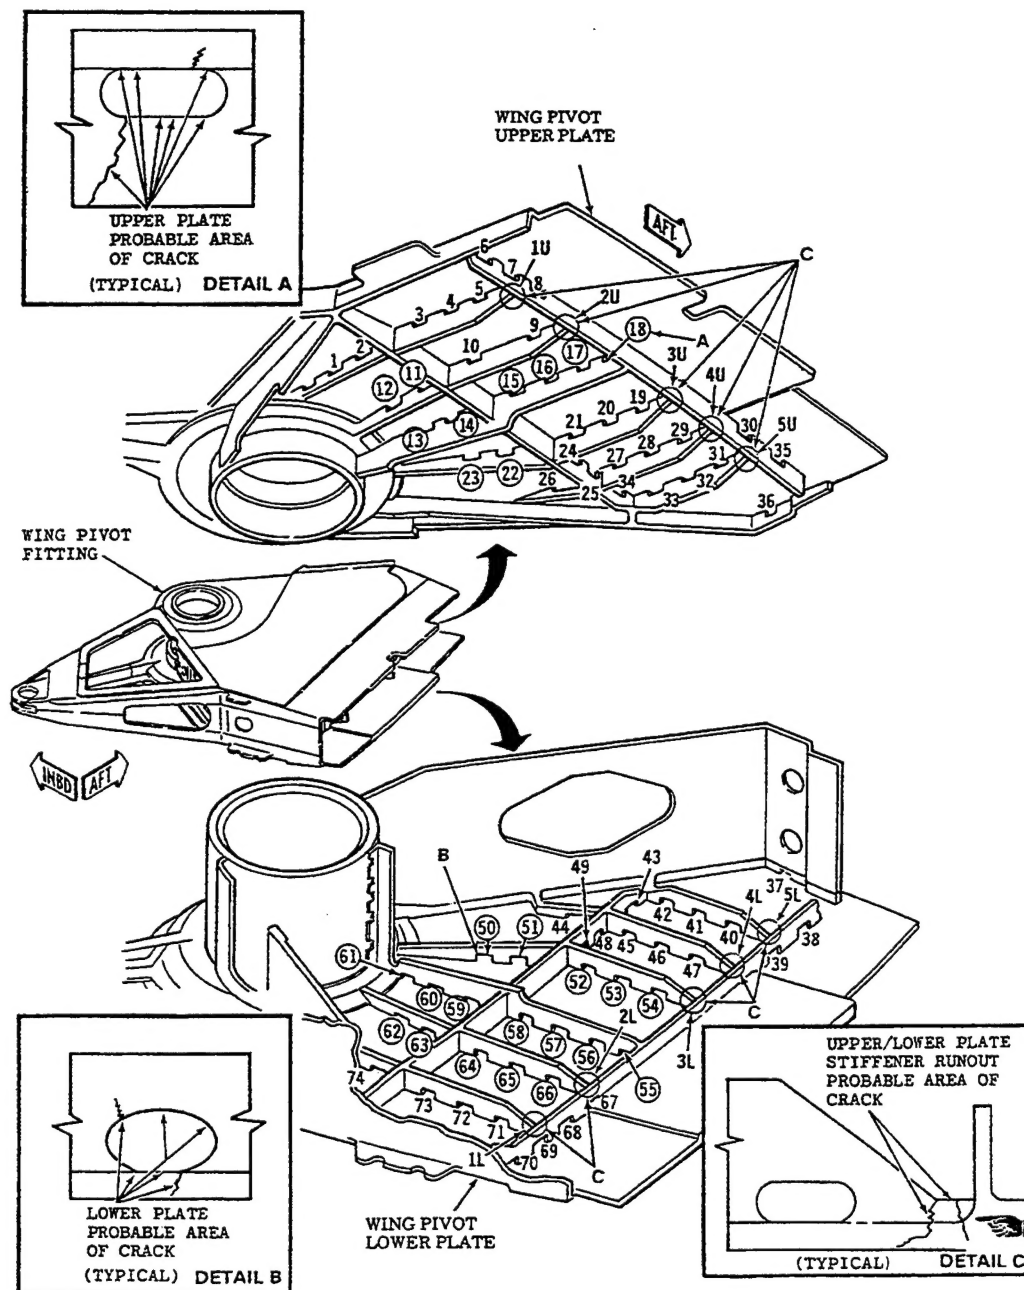
Figure 2: F-111 wing pivot fitting details

Cracking has occurred in regions of reducing stiffener height known as stiffener runouts (SRO), and around elongated holes known as fuel flow vent holes (FFVH). Areas of local stress concentration, referred to here as 'hot spots', are predominantly found at FFVHs and SROs, hence these features have been a main focus of this investigation. Figure 2 shows the locations of all FFVHs and SROs in the WPF.

Two well-known critical sites in the upper plate of the WPF are FFVH 13 and SRO 2U². Both exhibit very high stress concentrations and both have experienced numerous in-service cracks [3, 4, and 5]. Furthermore, these items are two of the control points for the F-111 DADTA. A significant amount of work has been directed toward managing these sites [4-11]. Recent instances of cracking at FFVHs 11 and 12 [12] indicate that other areas may also be cause for concern, especially as the aircraft moves into the latter stages of its planned operational life.

The peak stresses occurred at locations along the FFVHs and SROs where in-service cracking also occurs, as shown in Figure 2. These locations are the lower inboard corner of the upper plate FFVHs, the upper inboard corner of the lower plate FFVHs, and the corner radius of the SROs, both in the upper and lower plates. The upper plate peak stresses are compressive while the lower plate peak stresses are tensile.

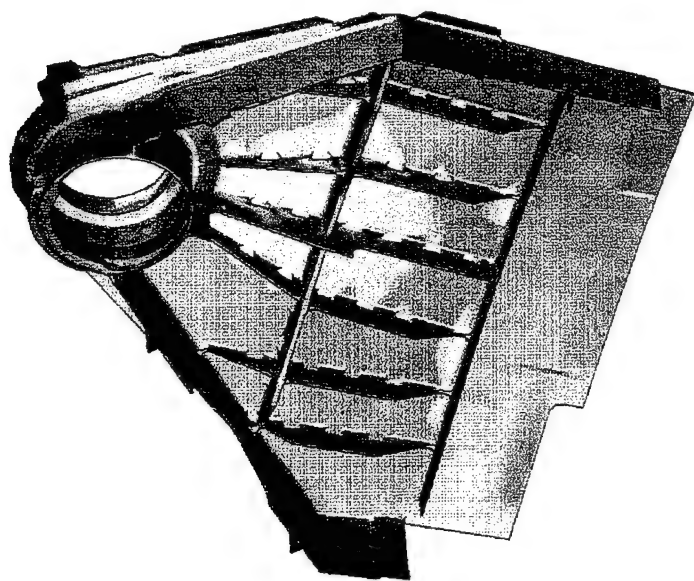
Figure 4: *Stress contour plot of the WPF upper plate*

Prior to any mesh refinements, stress results were extracted from the current model to identify areas requiring further investigation. The peak von Mises stresses from each FFVH and SRO were tabulated. This, in combination with a qualitative visual

inspection of stress contour plots (Figures 4 and 5) and an examination of full-scale test data, was used to select the most severe locations.

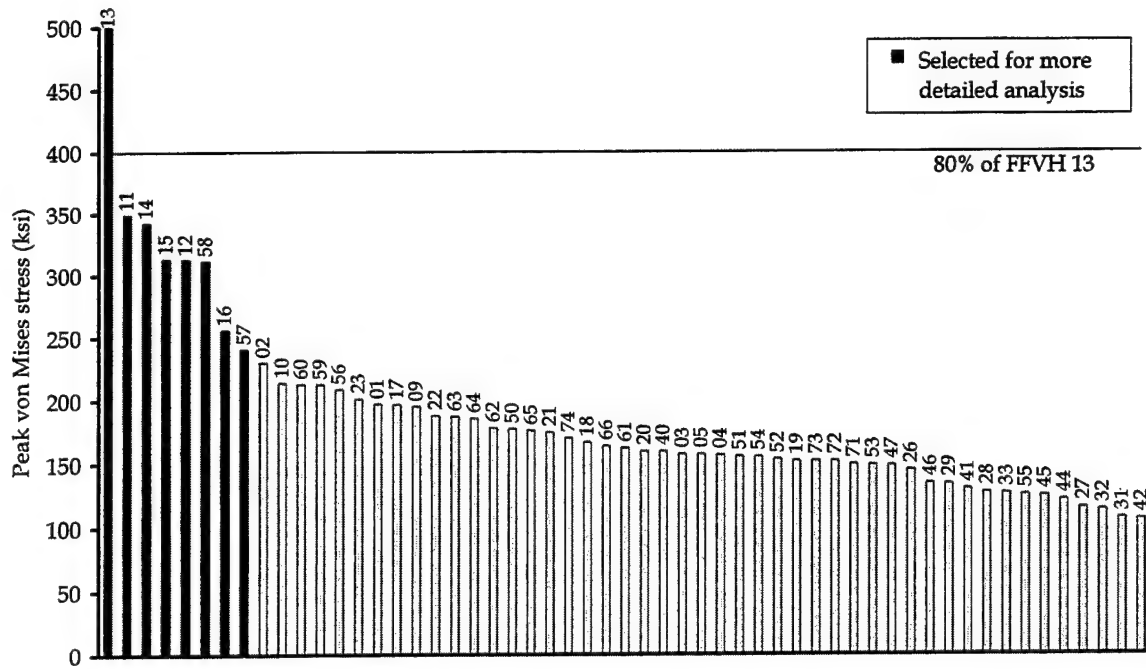
Figure 6: Preliminary peak stress results for each fuel flow vent hole (+7.33 g load case)

Figures 6 and 7 show the preliminary peak stresses at each FFVH and SRO. The results are also tabulated in Appendix B. On the basis of these results the following items were selected for further investigation:

- FFVHs 11, 12, 13, 14, 15, and 16 in the WPF upper plate
- FFVHs 57 and 58 in the WPF lower plate
- SROs 2, 3, 4 in the WPF upper plate
- SRO 3 in the WPF lower plate

SRO 5 in the upper plate was also included in this group after a review of full-scale strain survey data [13]. For the +7.33 g load case the test data clearly shows yield conditions for this SRO similar to SRO 3 and SRO 4. This was not evident from the preliminary FE results.

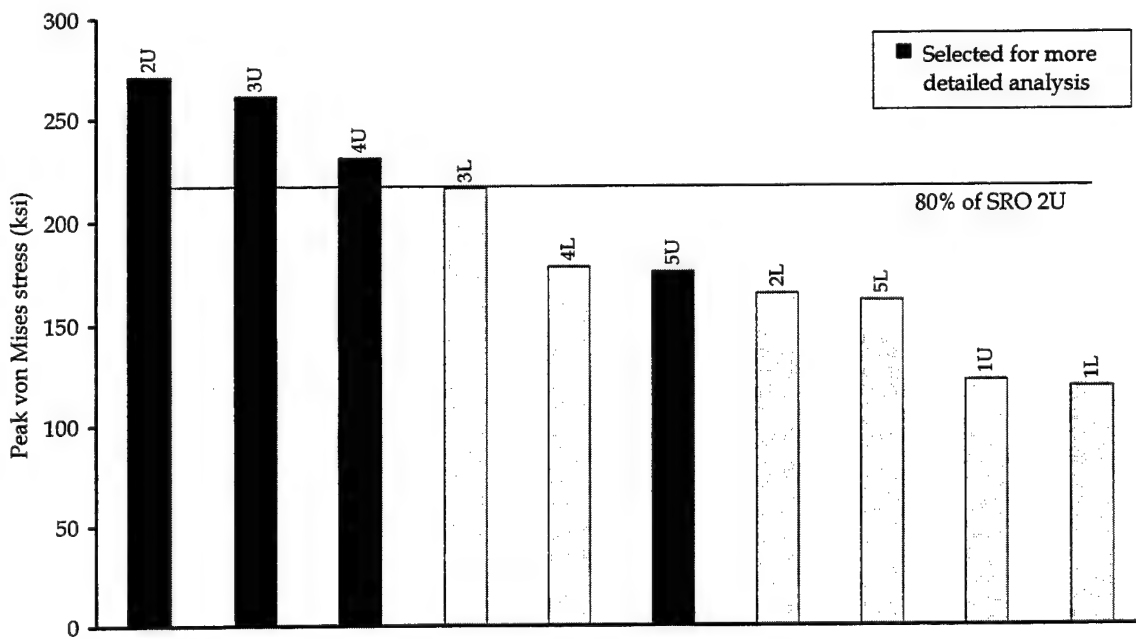
Figure 7: Preliminary peak stress results for each stiffener runout (+7.33 g load case)

The magnitude of the peak stress at SRO 3L is approximately 80% of the SRO 2U value and the stresses there are tensile for positive loads. Although it may experience a relatively high tensile spectrum during flight conditions, it is not considered as critical due to an expected residual compressive field after CPLT loading. This would have a beneficial effect on fatigue crack growth. A similar scenario would apply to all lower plate SROs. For this reason, no detail stress analysis has been performed at SRO 3L in this investigation, as it may be inappropriate to use the stress results alone to compare this location with upper plate SROs. A DADTA analysis, which would account for the residual compressive stress field, would be required in order to assess correctly its relative cracking potential.

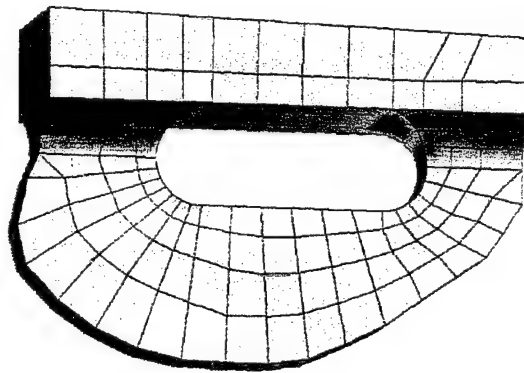
Figure 9: Stress contour plot of FFVH 13

Figures 9 and 10 show typical stress contour plots for FFVH 13 and SRO 2U respectively.

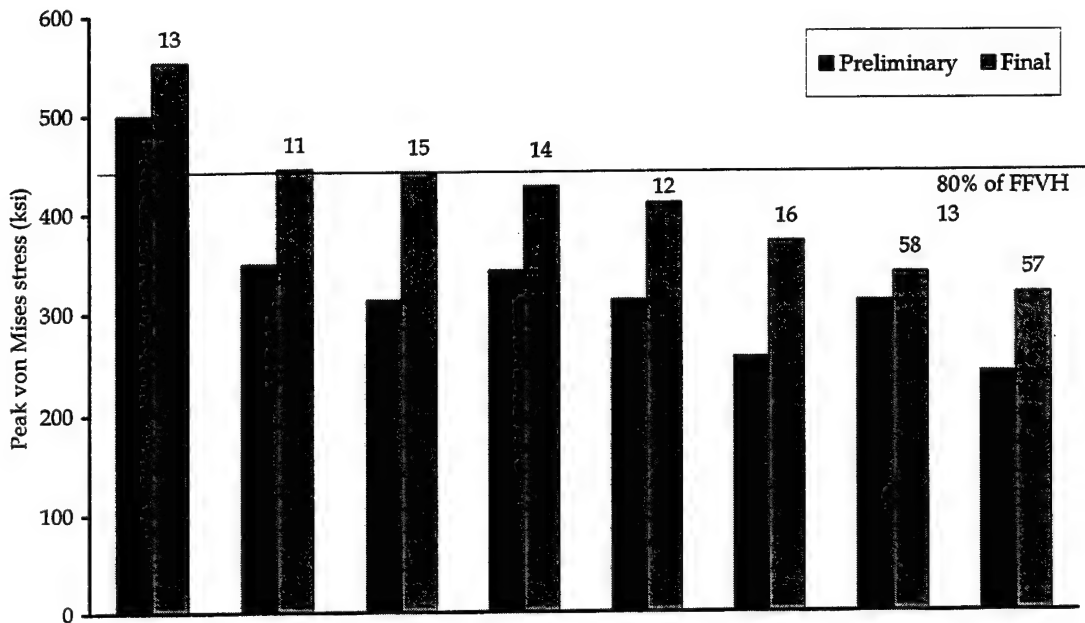
Figure 11: Preliminary and final peak stresses at selected FFVHs (+7.33 g load case)

Table 1 summarises the final peak von Mises stress at each FFVH as determined from the detail stress analysis. These are represented graphically in Figure 11, with the preliminary results included for comparison. As can be seen, the mesh improvements have resulted in a marked increase in the peak stress. For FFVHs 13 and 58 the increase is relatively small since the initial meshes at these locations were of reasonable quality. Conversely, there is a large increase in the peak stresses indicated at FFVHs 15 and 16, for which the initial meshes were very poor.

As expected FFVH 13 shows the most severe peak stress. FFVHs 11, 12, 14, and 15 exhibit approximately similar stress levels at about 80% of the FFVH 13 level. FFVH 16 is less severe at 67% while FFVHs 57 and 58 are around 60%.

For each upper plate FFVH (11 to 16) the peak stress occurs in the lower inboard corner, and is compressive for the load case considered. A significant but lesser peak (typically 80% of lower inboard value) is also evident in the upper outboard corner. For each lower plate FFVHs (57 and 58) the peak stress occurs in the upper inboard corner, and is tensile for the load case considered.

Table 1 also highlights vent holes that are known to have experienced in-service cracking in the RAAF fleet. Numerous cracks have been found at FFVH 13, while only a few cracks have been found at the other vent holes [3].

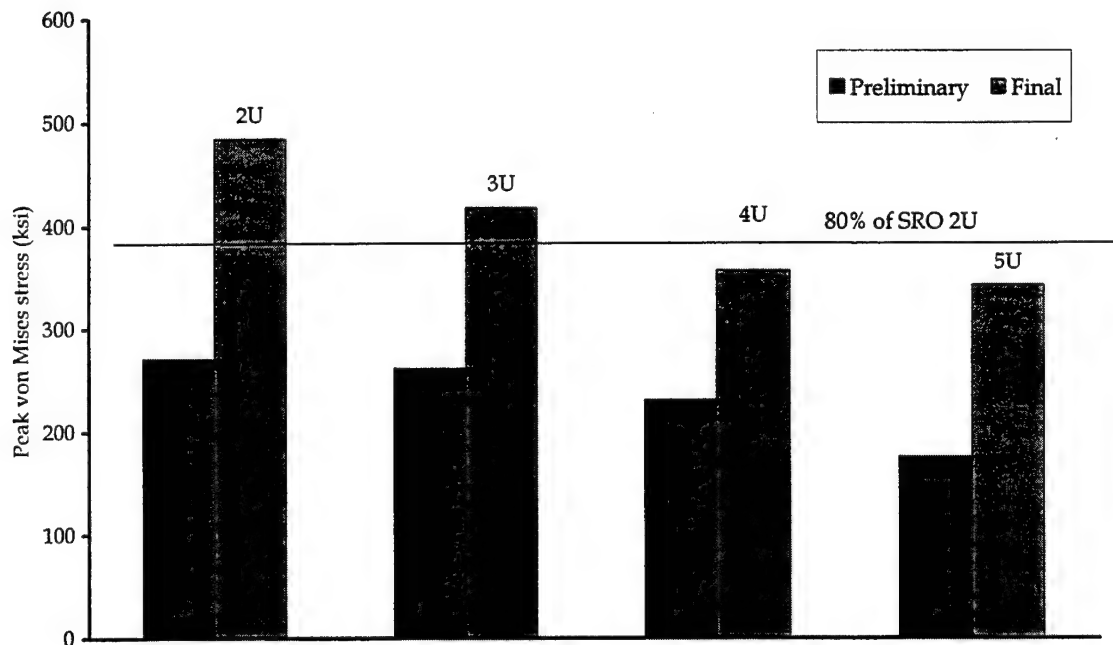
Figure 12: Preliminary and final peak stresses at selected SROs (+7.33 g load case)

Table 2 summarises the final peak von Mises stress at each SRO as determined from the detail stress analysis. The results are shown graphically in Figure 12, with the preliminary results included for comparison. As can be seen, SRO 2U is the most severe, followed by SRO 3U, SRO 4U and SRO 5U. The peak stresses at these SROs are compressive for the load case considered.

The detail peak stress results are much larger than the corresponding preliminary results with increases of up to 95%. This is due to the combined effect of the modelling adjustments in the SRO region and the very poor quality of the initial mesh.

Table 2 also highlights the runouts that are known to have experienced in-service cracking. Numerous cracks have been found at SRO 2U, while only a few cracks have occurred at the other runouts [3].
